Manhole Inspection Summary

Manhole # S45UU_031MH

Insp Date: **2/7/07 1:48 PM**

Location Address: **2761 TIVOLY AVE**

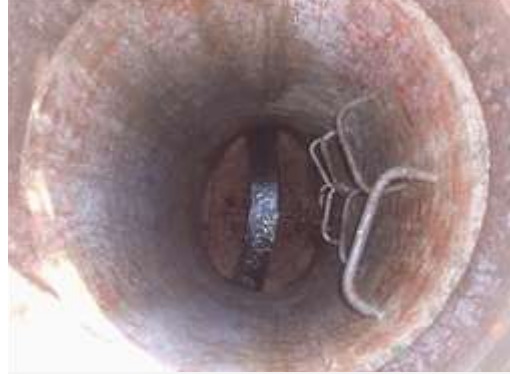
Top View

Barrel infiltration. Corroded steps.
Evidence of surcharge - Bench debris.

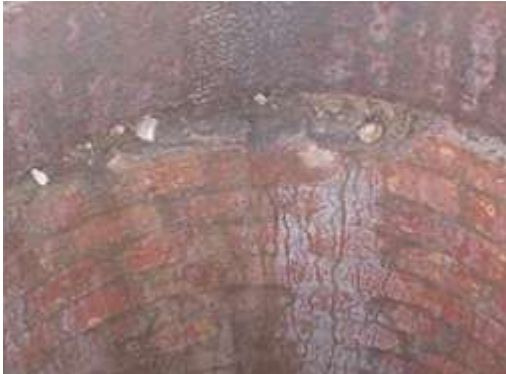
Defect

Frame leaks. Adjustment deterioration
and infiltration.

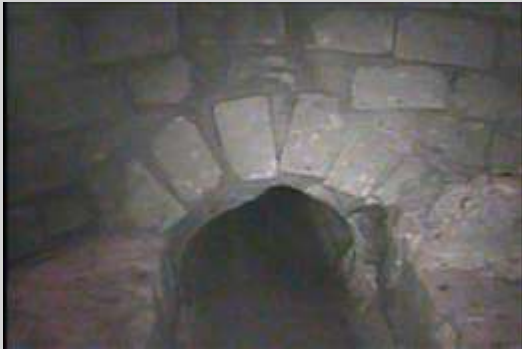
8 in. Circular Gravity Sewer Pipe Out @ 12 O'Clock

Infiltration: **Evidence** Pipe Seal Cond: **Broken**

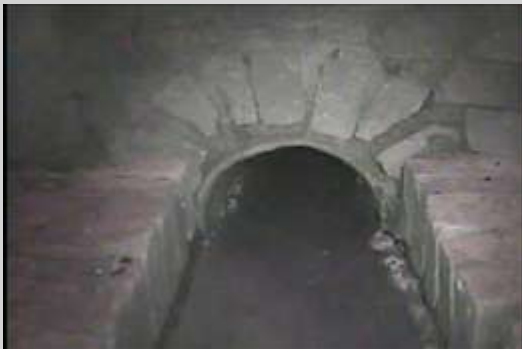
8 in. Circular Gravity Sewer Pipe In @ 7 O'Clock

Deposits: ☐ None ☒ **Mud** ☐ Sludge ☒ **Debris** ☒ **Grease**

Silt Depth: **1** (in.) Deposits Extent: **Light**
